A CULTURAL RESOURCES ASSESSMENT  
OF SELECTED MAGNETIC ANOMALIES  
FREEPORT HARBOR, TEXAS  
45-FOOT PROJECT

by  
Clell L. Bond

A report submitted to the U.S. Army Corps of Engineers,  
Galveston District, by the Texas A&M Cultural Resources  
Laboratory in partial fulfillment of Purchase Order  
Number DACW64-80-M-0869.

November, 1980

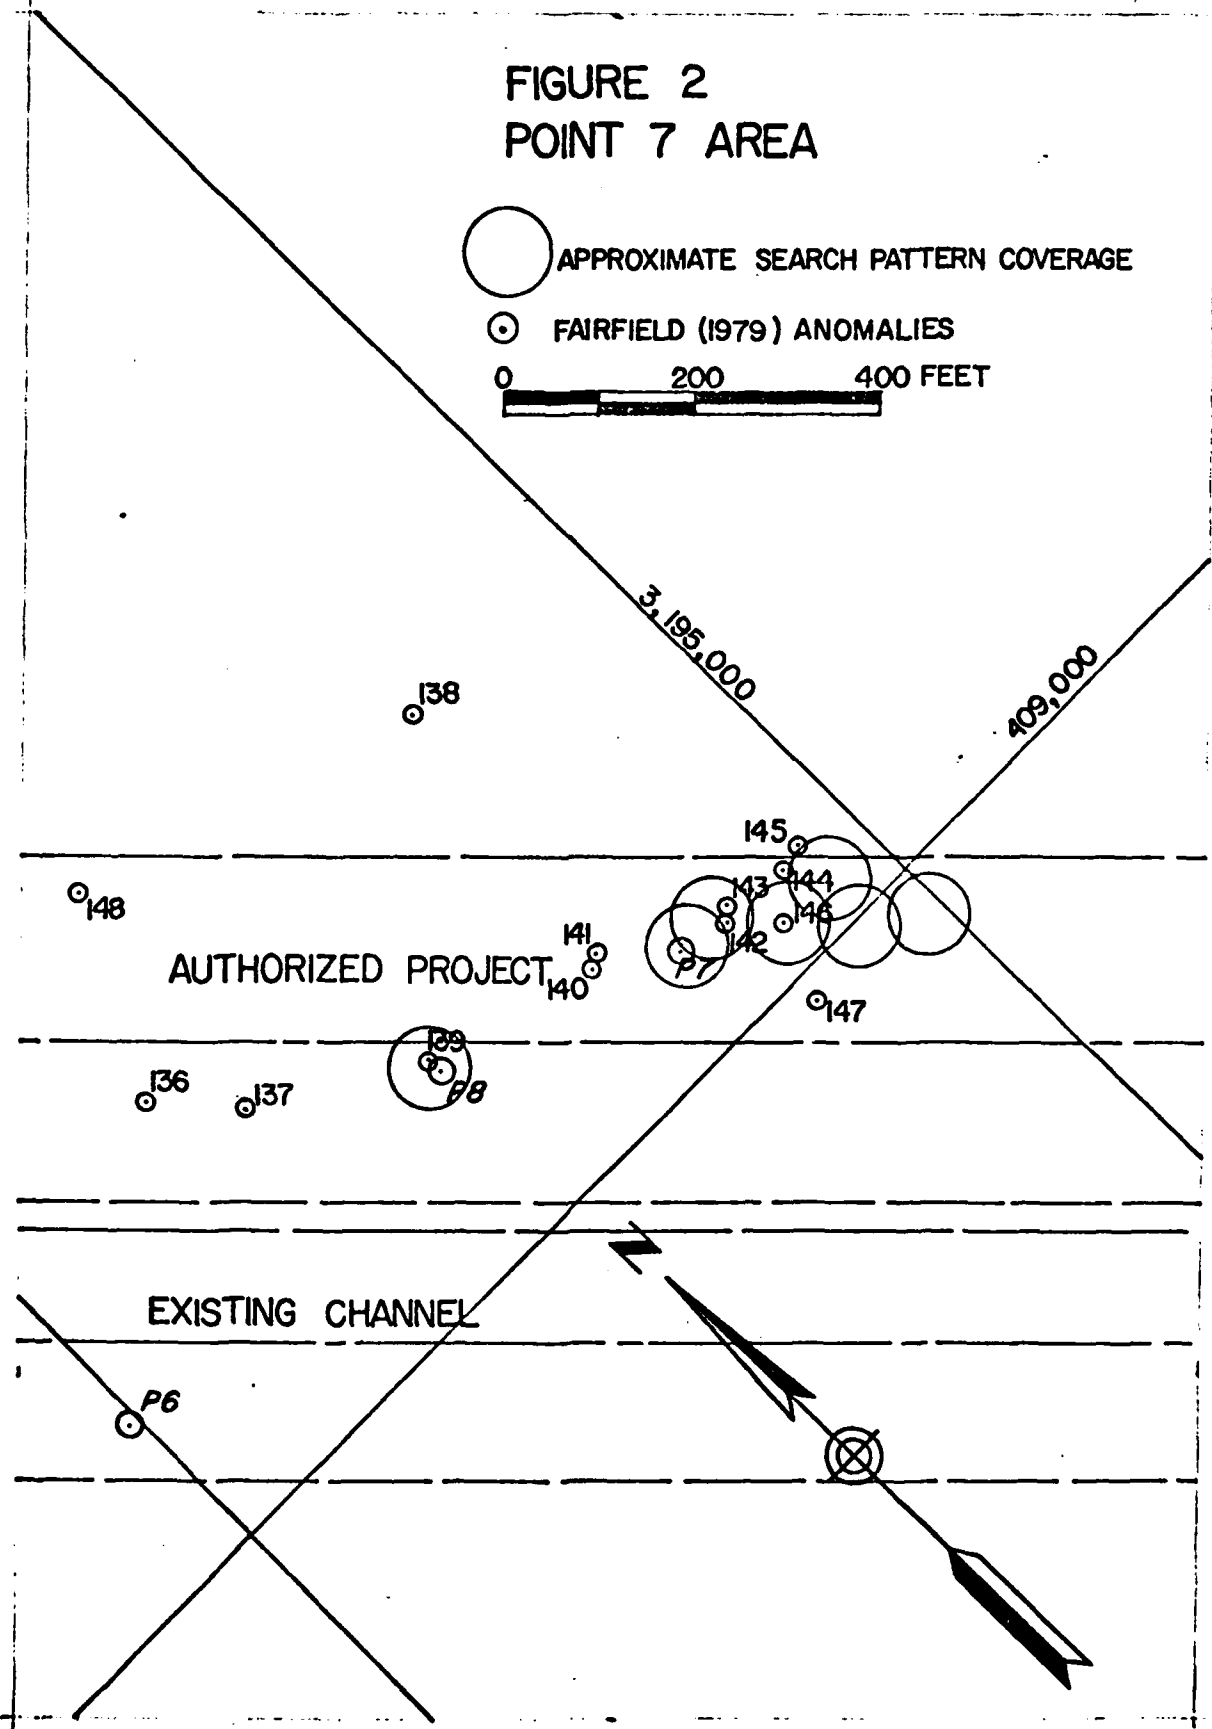
FIGURE 2  
POINT 7 AREA

Point 7 (Figure 2): Dive 3. Positioned approximately 15 m east of Point 7 in approximately 13.5 m of water, the investigating divers found a smooth clay bottom. The clay was noted to be firm but very cohesive under a 10-15 cm thick layer of suspended and/or partially suspended clay particles.

Dive 4. Centered over Point 7, the divers found a smooth undisturbed clay bottom.

Dive 5. Bouyed over anomaly 145, the bottom predominantly consisted of smooth clay although some minimal bottom disturbance seems to have occurred in the eastern portion of the search area.

Dive 6. Located approximately 20 m east of anomaly 145, the search pattern again found a uniform clay bottom with a single groove of 0.5 m wide by 0.5 m deep gouged in the clay. A single waterlogged driftwood fragment of approximately 10 cm in diameter and 20 cm in length was recovered.

Dive 21. Positioned over or very near anomaly 139 in 12.6 m of water, the magnetometer indicated a 12 gamma point source. The divers found a relatively smooth clay bottom but failed to locate any materials which might have caused the 12 gamma magnetometer reading.

Dive 22. This search was centered over an 11 gamma anomaly approximately 25 m southeast of plotted anomaly 146. The divers found a dredge scar in the clay bottom, a modern fire brick fragment reading "...LLSUILLE...AVAGE," a one m length of very rusty welded link chain (approximately five cm link length), two very rusty sheet iron fragments and one small fragment of friable (charred?) wood.

Dive 23. Located 46 m due east of anomaly 146, this dive was to examine a magnetometer-indicated 10-11 gamma anomaly source. No anomaly source was located by the search.

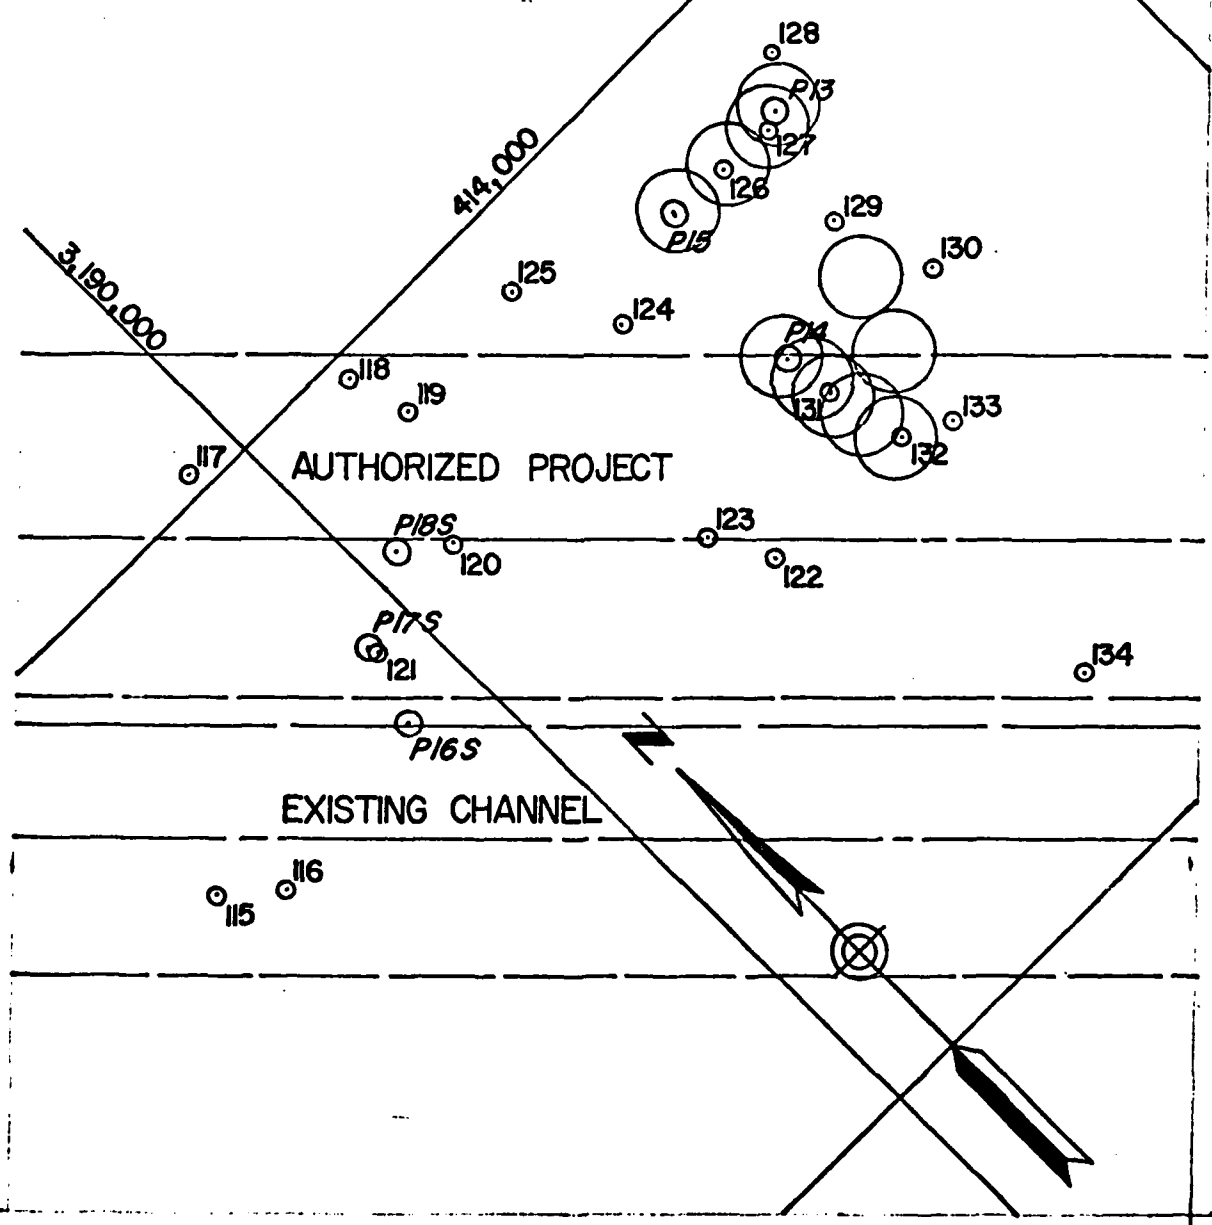
FIGURE 3  
POINT 13,14 AND 15

Point 13 (Figure 3): Dive 7. Centered over Point 13, the dive was made in 12 m of water and found a relatively smooth clay bottom and a single small waterlogged driftwood fragment.

Dive 8. This search was centered off an anchor set approximately 12 m west of Point 13 near anomaly 127. The divers found a smooth clay bottom and a single somewhat corroded 12 oz beverage container bearing the barely legible label "Miller Lite."

Point 14 (Figure 3): Dive 11. Centered on the buoy set on Point 14, the dive encountered a clay bottom gouged with at least two dredge scars of approximately 1.5 m in width and up to 0.5 m deep.

Dive 12. Dive 12 was made off of a boat anchor set over anomaly 131. The divers found that the clay bottom had been marred by a number of dredge scars. A short length (1-1.5 m) of nylon rope (approximately 3 cm in diameter) was found.

Dive 13. Centered between anomalies 131 and 132, the search found a dredge-damaged bottom consisting predominantly of clay and a light scattering of apparently disturbed oyster shells. A modern waterlogged board of approximately 2 cm X 15 cm X 1 m was recovered in the search.

Dive 14. Dive 14 was made from an anchor located on anomaly 132. The divers reported finding numerous dredge scars in the clay bottom, a few scattered oyster shells and a small thin lens of sand mixed with shell. No artificial materials were located.

Dive 15. Placed roughly 37 m east of Point 14, the divers found only a few shallow dredge trenches in the clay and a thin scattering of oyster shell fragments.

Dive 16. Centered approximately at the midpoint between Point 14 and anomaly 131, this dive rechecked the area examined by dives 11 and 12, again with negative results.

Dive 17. Dive 17 was conducted from an anchor approximately 37 m south-east of Point 14 and overlapped two of the previously checked search patterns. Additional disturbances were noted on the clay bottom; however, no cultural debris was found.

Point 15. (Figure 3): Dives 1 and 2. Essentially these two dives were tests conducted to determine visibility and bottom conditions. After brief exploratory free-swimming bottom searches, the divers determined that a tethered technique would be required to provide an adequate search pattern. Artificial illumination was found to be of no assistance in the light-diffusing, turbid waters near the bottom.

Dive 9. This circle search was conducted off a boat anchor which was set over anomaly 126. A smooth clay bottom was encountered.

Dive 10. This dive was centered off a buoy anchor set at Point 15. The divers found a smooth clay bottom which was cut with a single long, narrow (0.5 m wide and 10.5 m deep) groove. A very corroded aluminum beverage can was recovered.

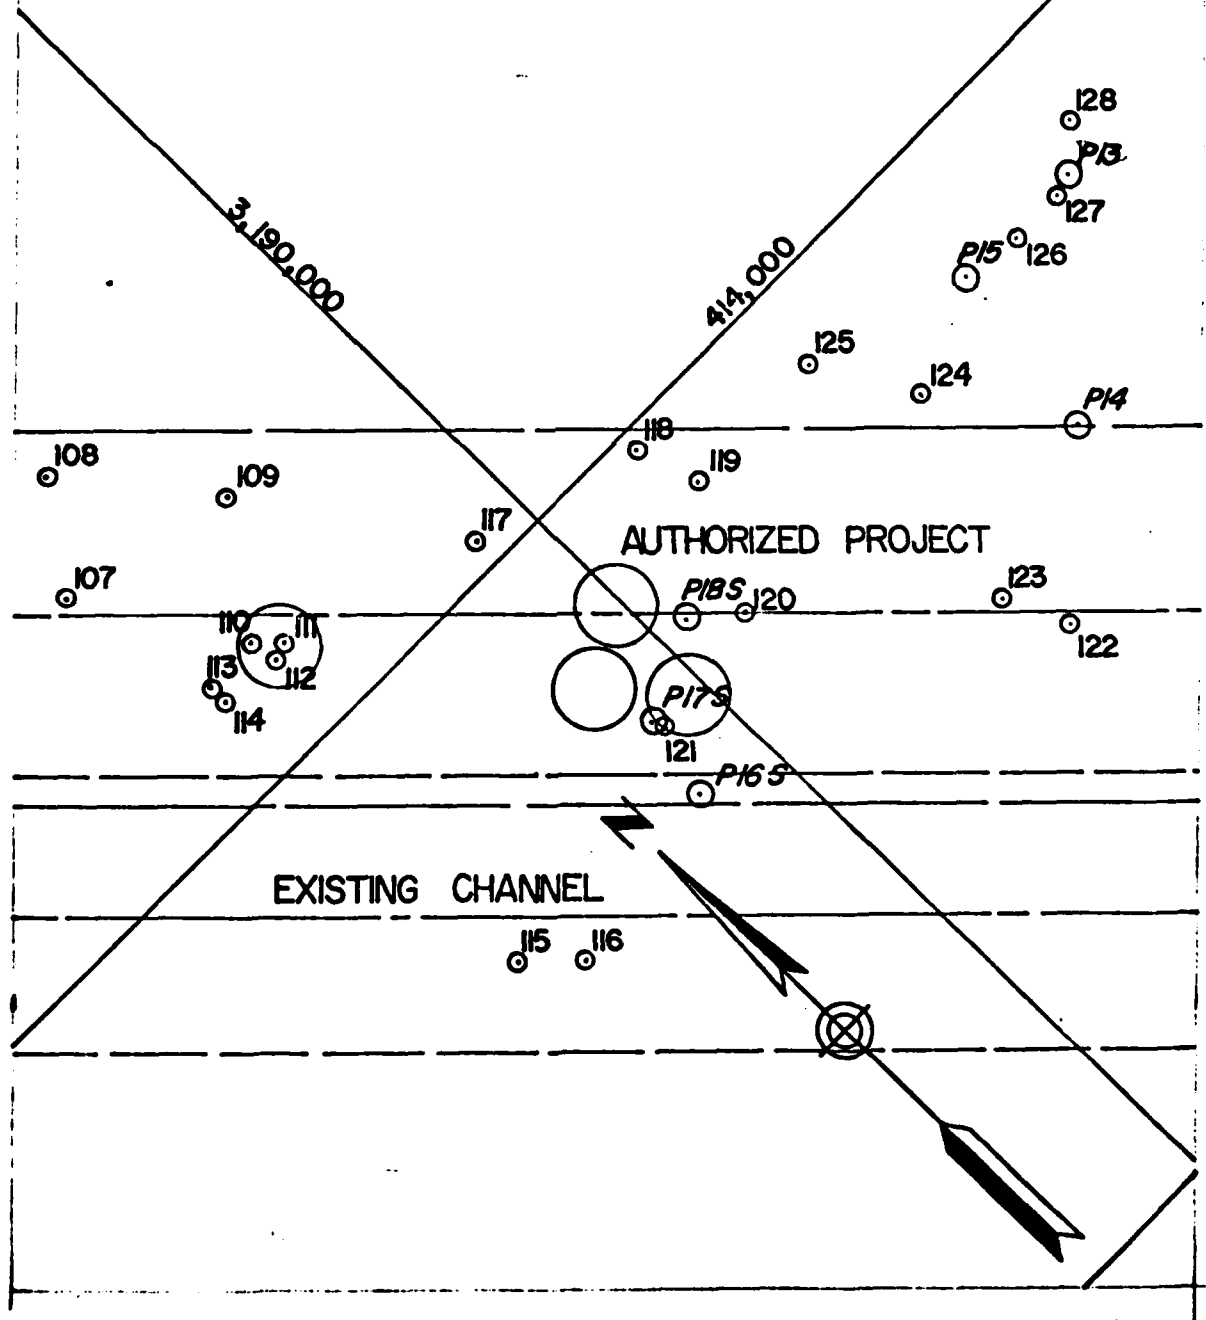
# FIGURE 4 POINT 17 (AND 17 S) AREA

Point 17 (Figure 4): Dive 18. The only dive conducted in the immediate Point 17 area was centered on anomaly 111. The clay bottom was found to be extensively damaged by dredging. Trenches of over one meter in width and up to 1.5 m in depth made the bottom search difficult and hazardous. Except for a few shell fragments, nothing except bottom clay was found in the search.

Dive 24. Approximately 25 m north-northwest of Point 17 S over a 10 gamma magnetometer "hit", the divers found an extensively gouged bottom and a short length of wire rope. The recovered two fragments of wire rope were approximately one m in length, three centimeters in diameter and were badly corroded and encrusted.

Dive 26. Located approximately 37 m northeast of Point 17 S the divers found a dredge disturbance but failed to locate the cause of a 15 gamma magnetometer reading.

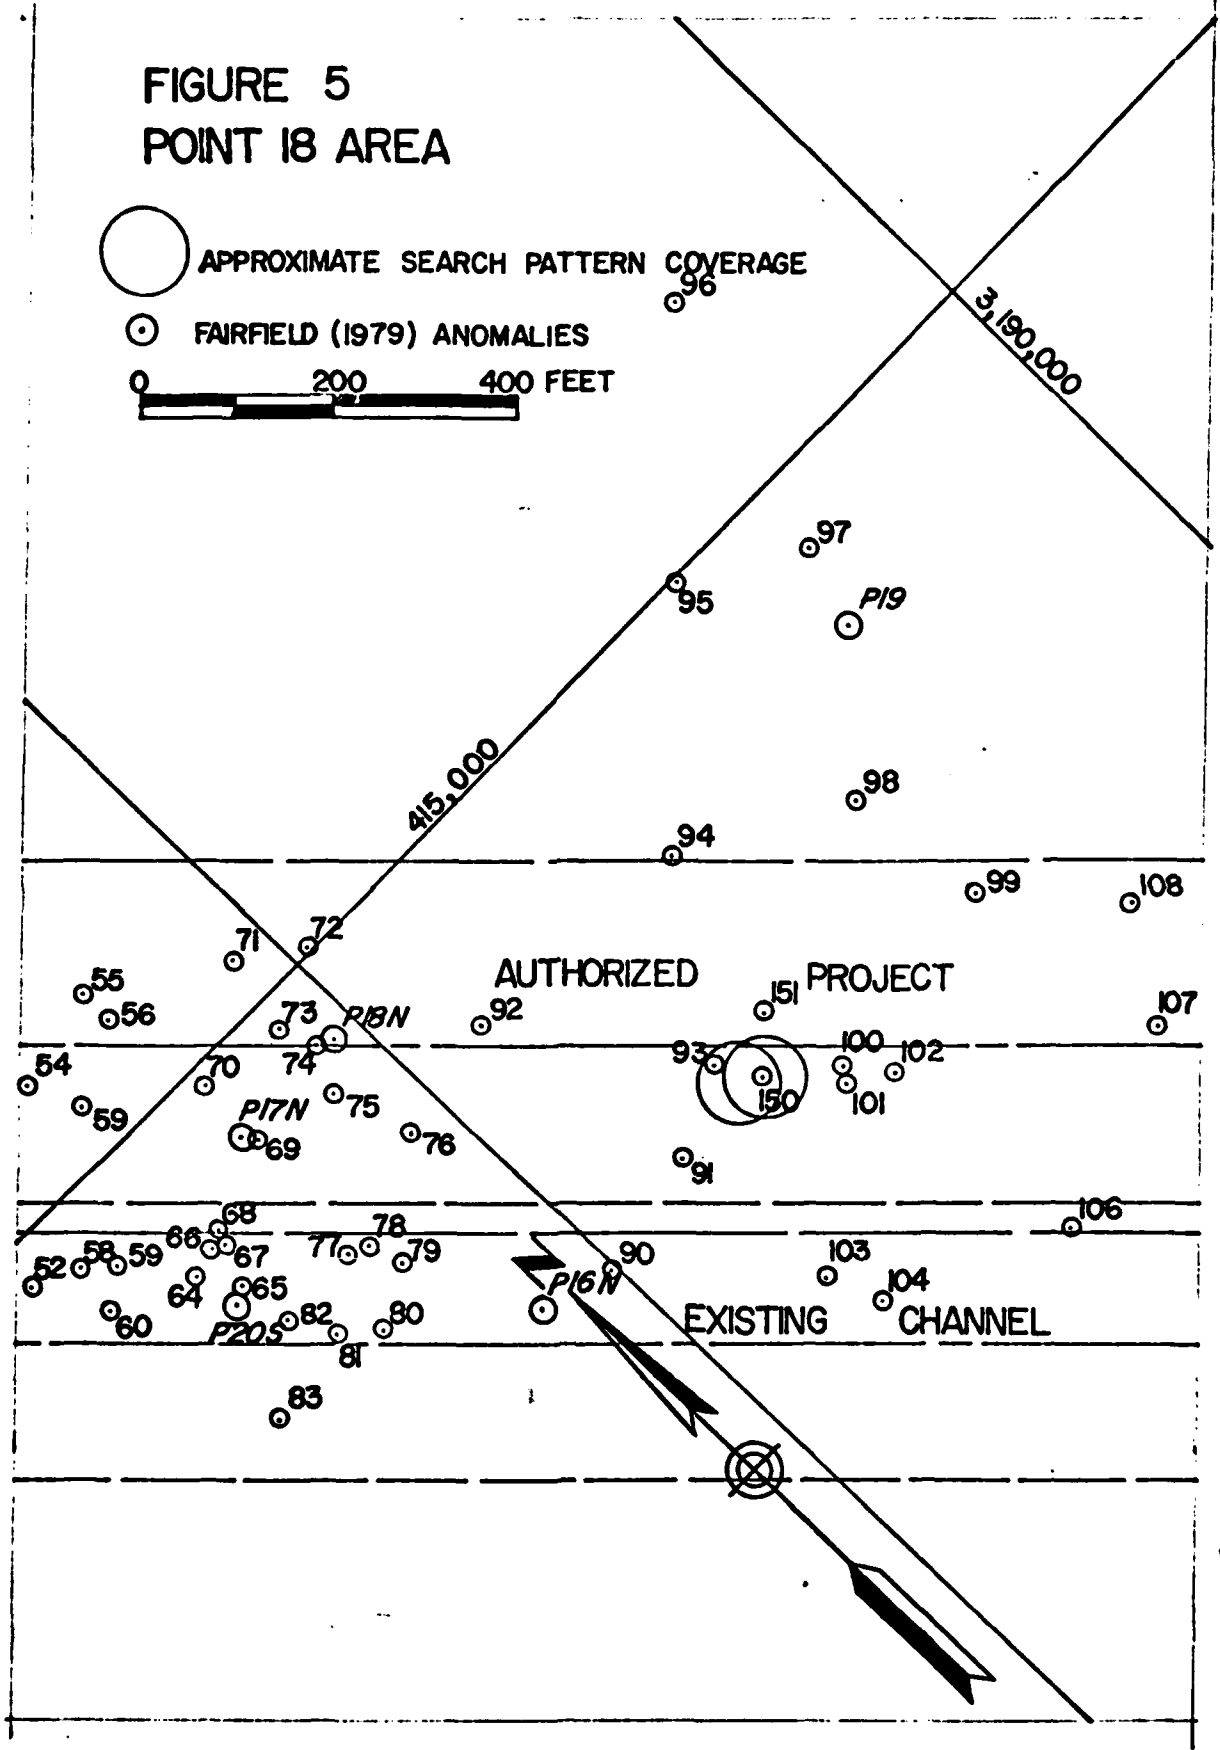
FIGURE 5  
POINT 18 AREA

Point 18 (Figure 5): Dive 19. The dive boat was anchored over anomaly 150 from which the search was centered. The dive team reported that the bottom clays were scarred by more trenches presumed to be dredge scars.

Dive 20. The dive was centered off Corps of Engineers point 18A about nine m northwest of anomaly 150 and overlapping the search area of dive 19.

The dredge disturbed condition of the bottom was reaffirmed. The dive team found a sunken treated piling of approximately 1.5 m in length lying horizontally on the bottom. The divers reported the object had metal fasteners and possessed only a small amount of marine growth.
